Pisinemo Intertie

PWSID No. 04000030

Sanitary Survey
March 24, 2016

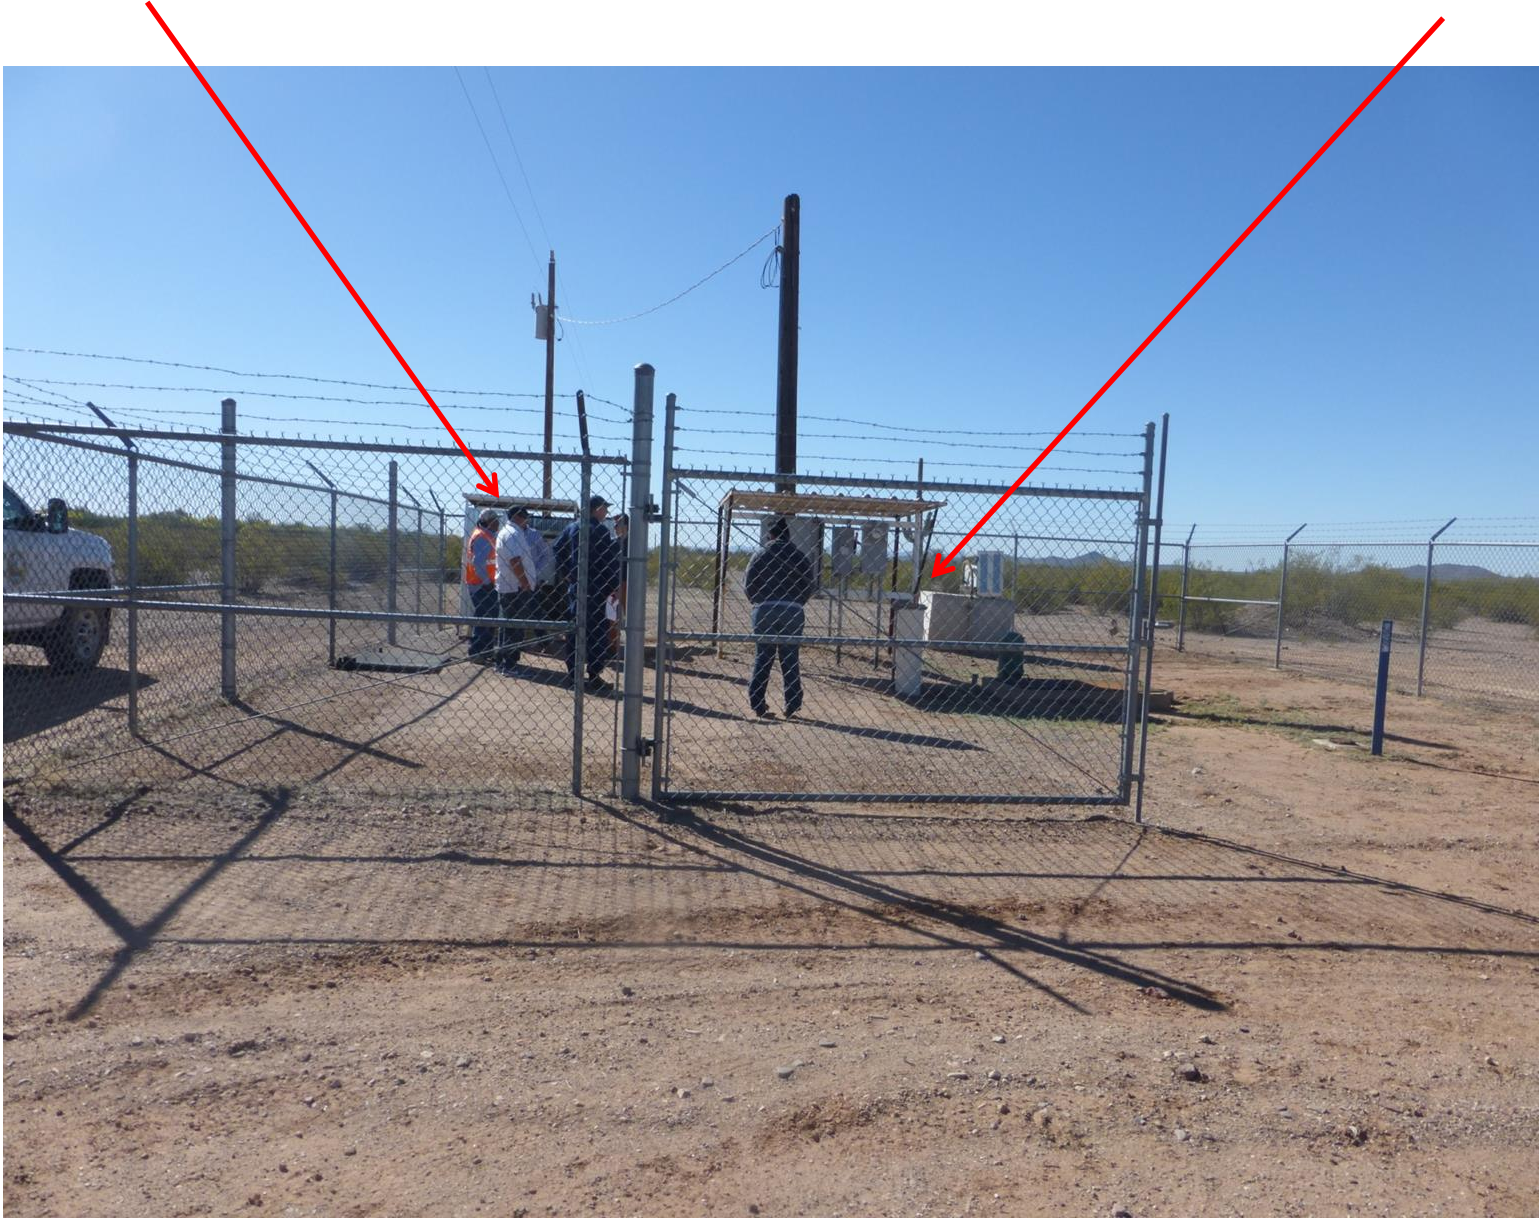
Well 3 (GW003)

This well is located within a locked fenced area approximately 4.3 miles southeast of the elevated storage tank in the Pisinemo community.

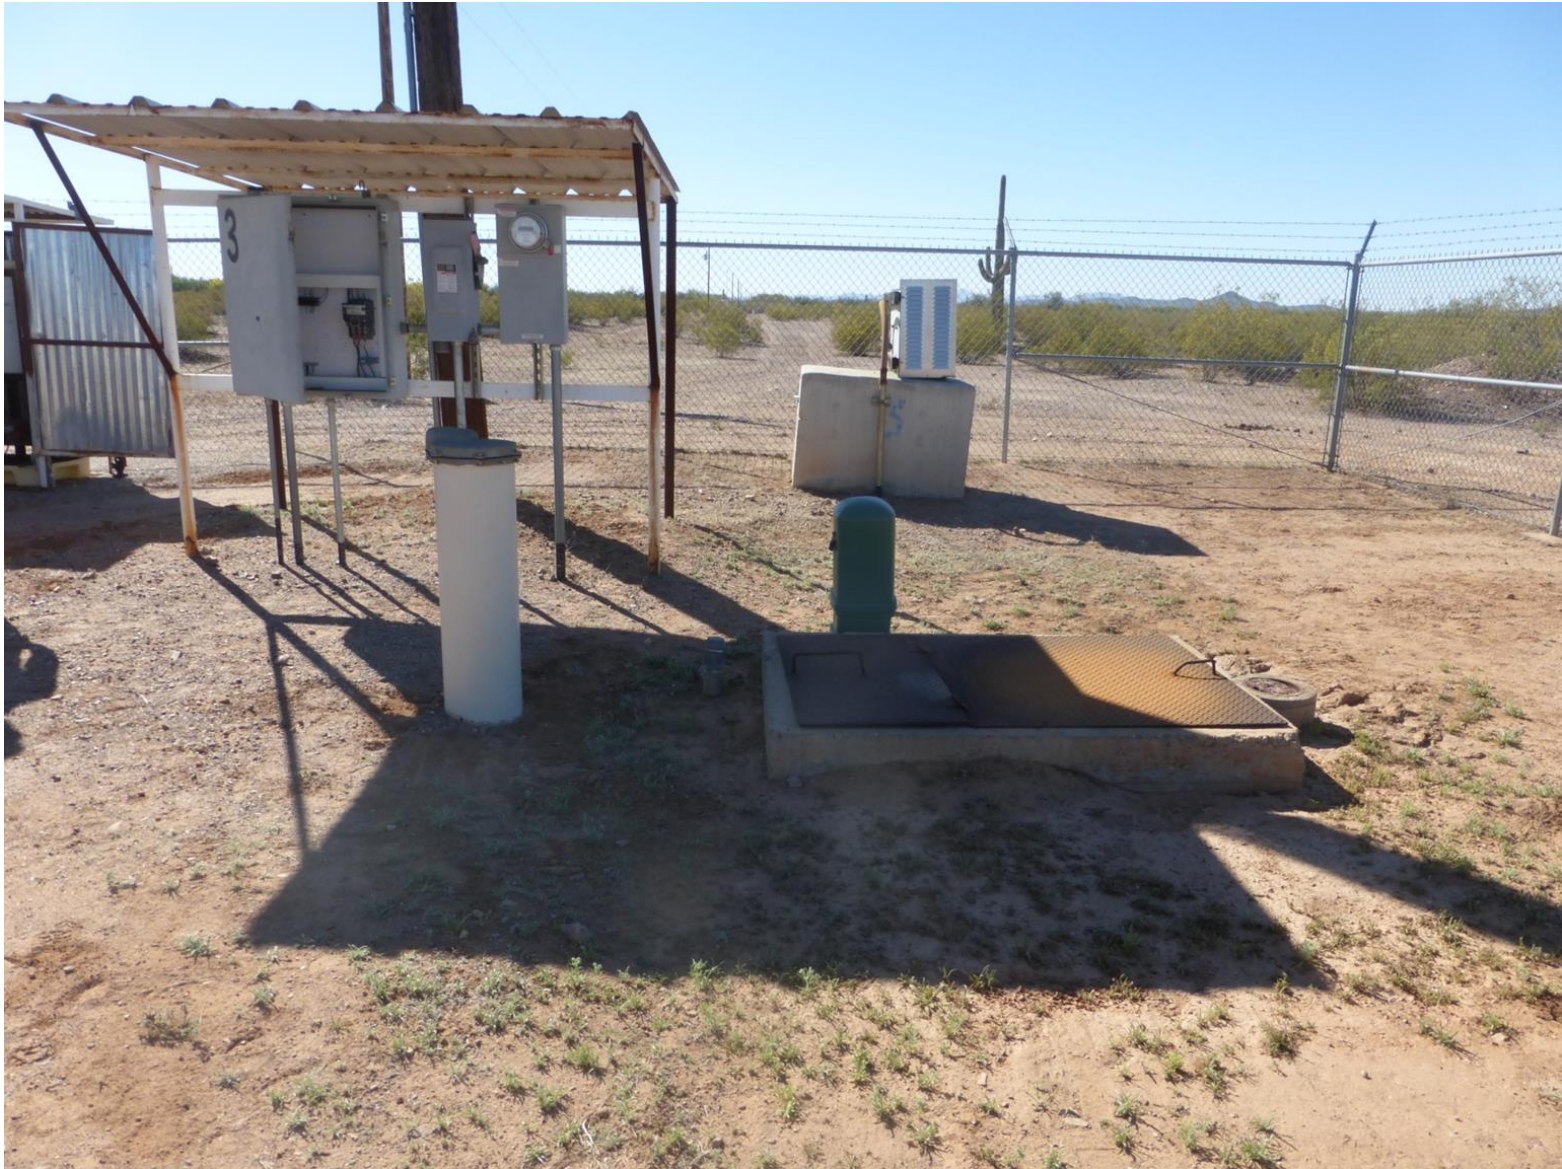
Information from TOUA indicates the well was drilled and cased to a depth of 500 feet on June 15, 1992. The casing is slotted between 353 and 500 feet. A pump test was completed in 1992 and indicated a static water level of 331.78 feet and a pumping water level of 350.43 feet at 101 gpm.

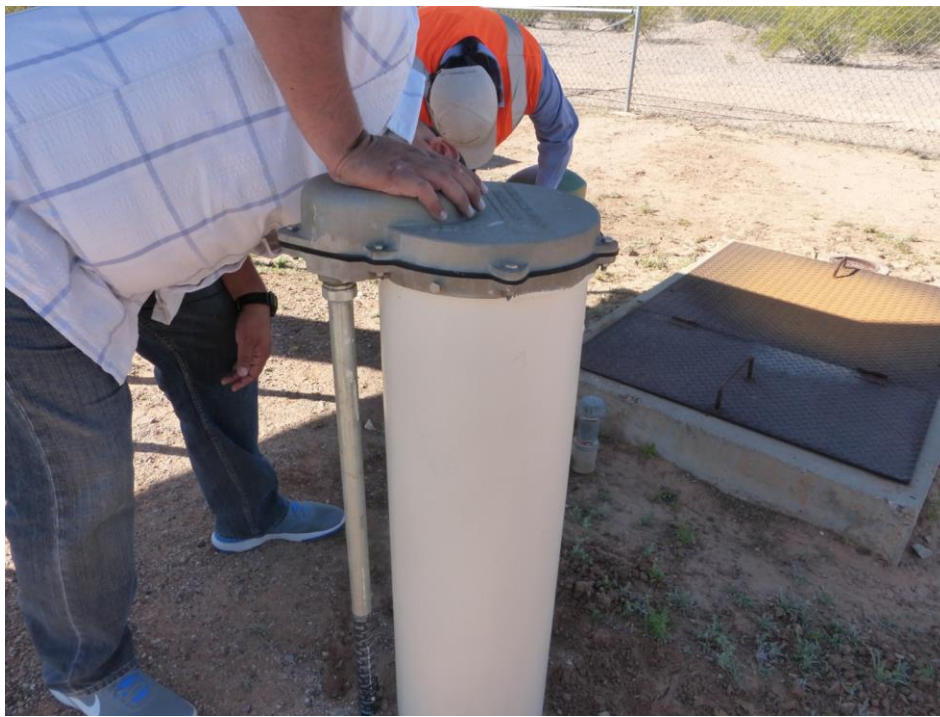
The pitless unit wellhead is equipped with a properly vented sanitary seal well cap.

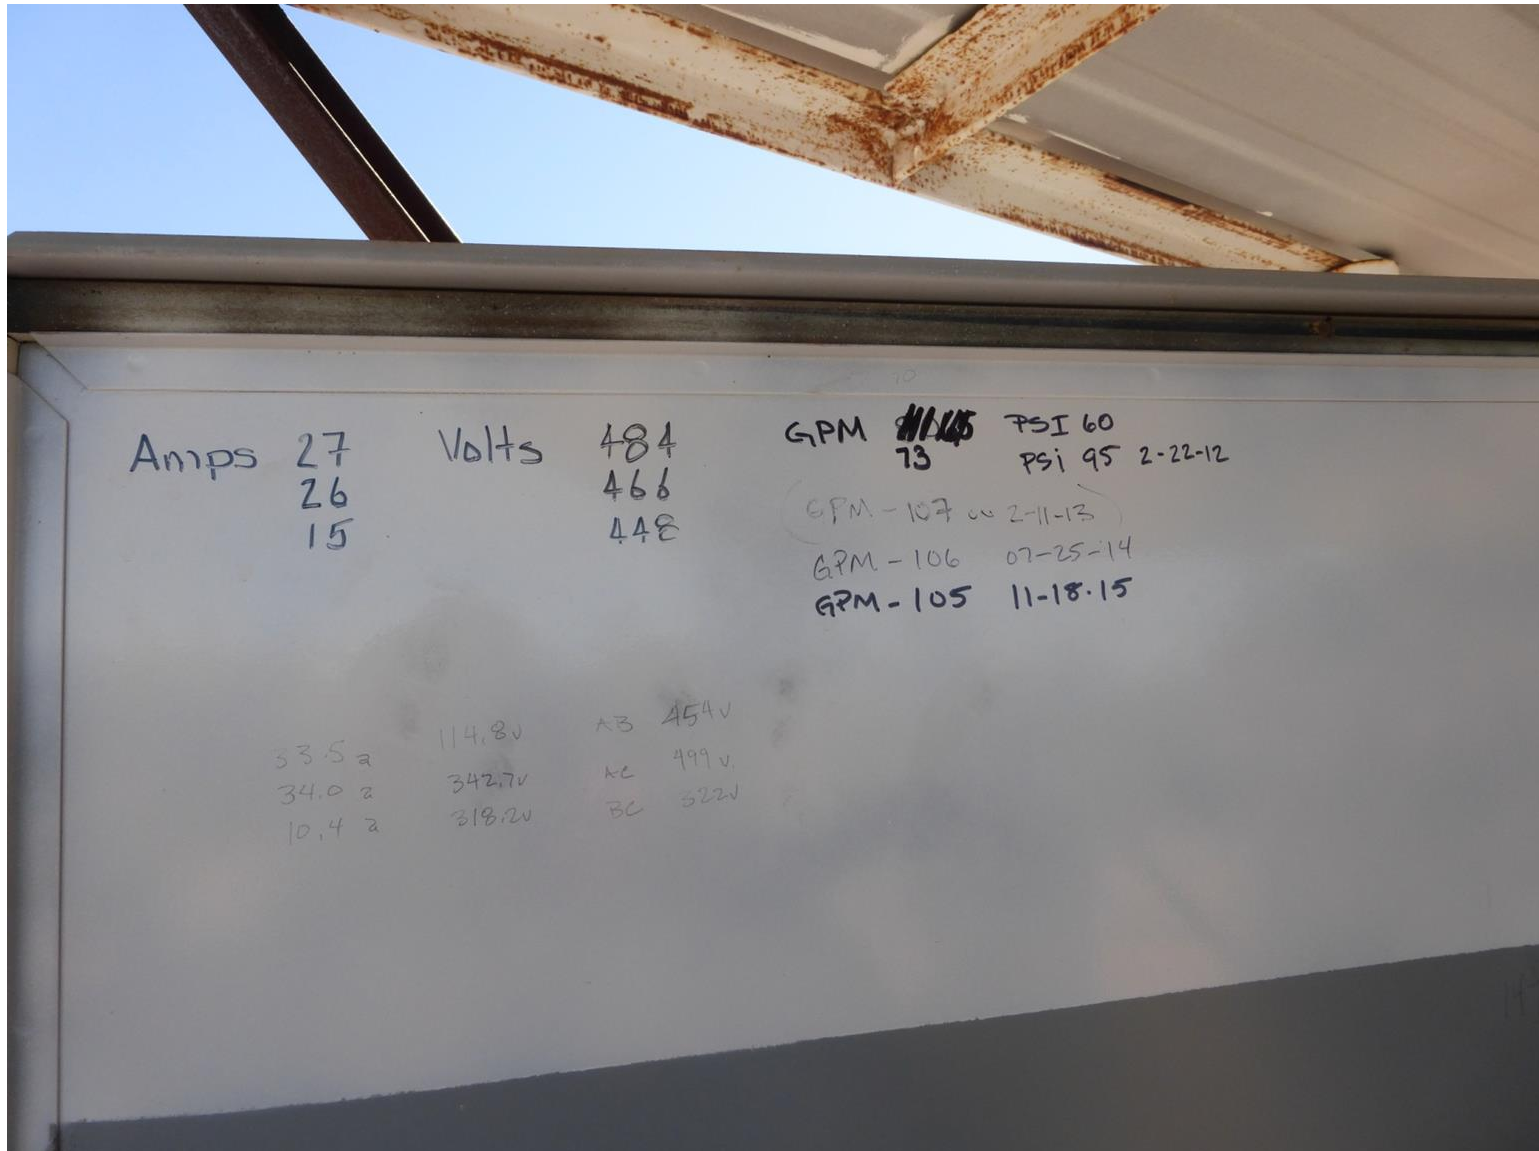
The well is equipped with a 20-hp submersible pump that produces approximately 105 gpm according to meter readings.

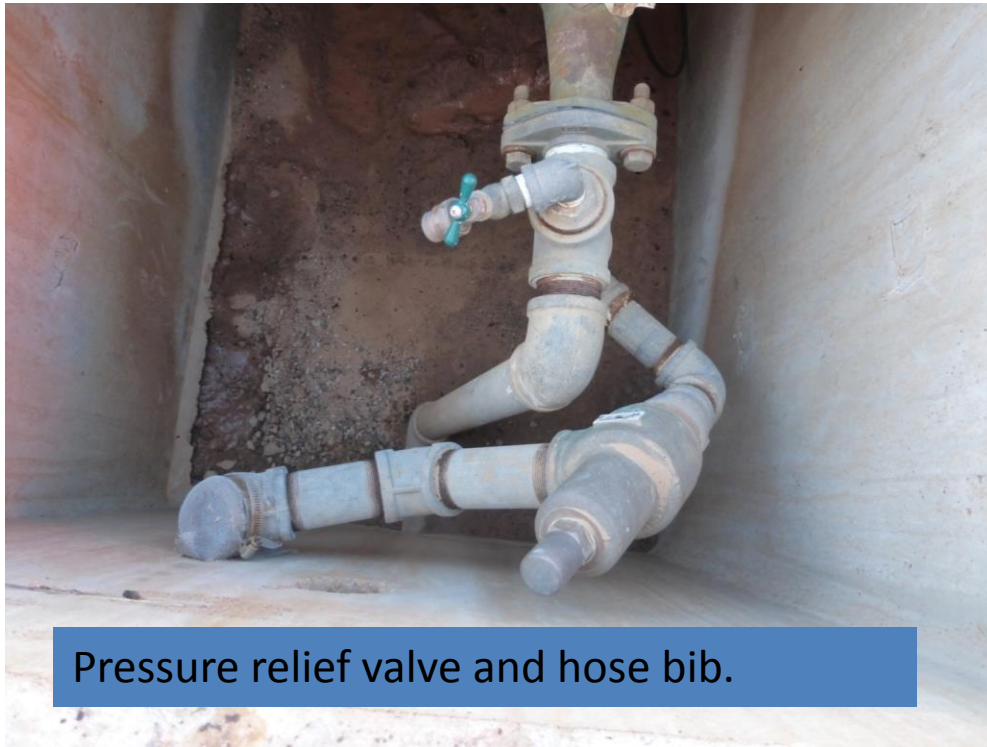
Pressure relief valve and hose bib.

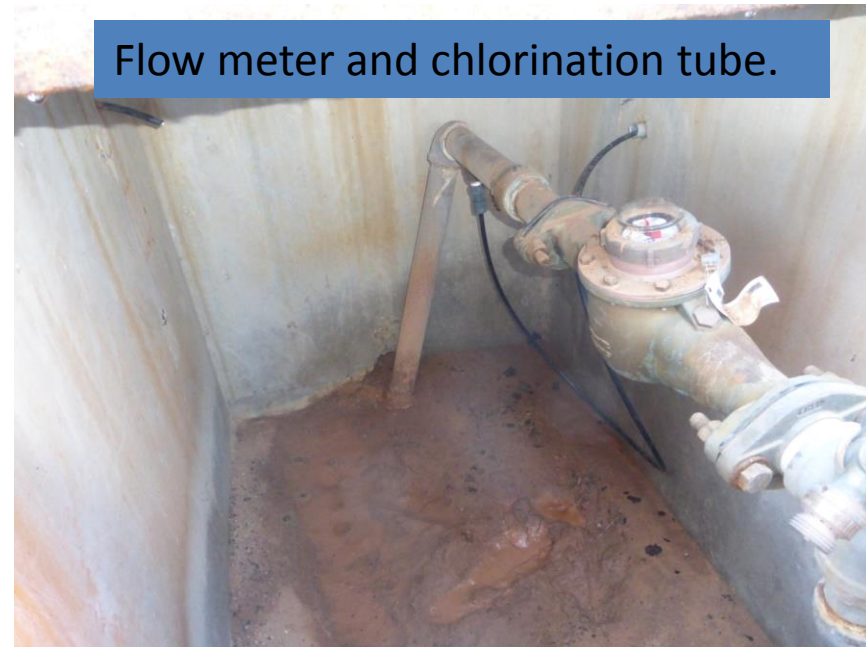
Flow meter and chlorination tube.

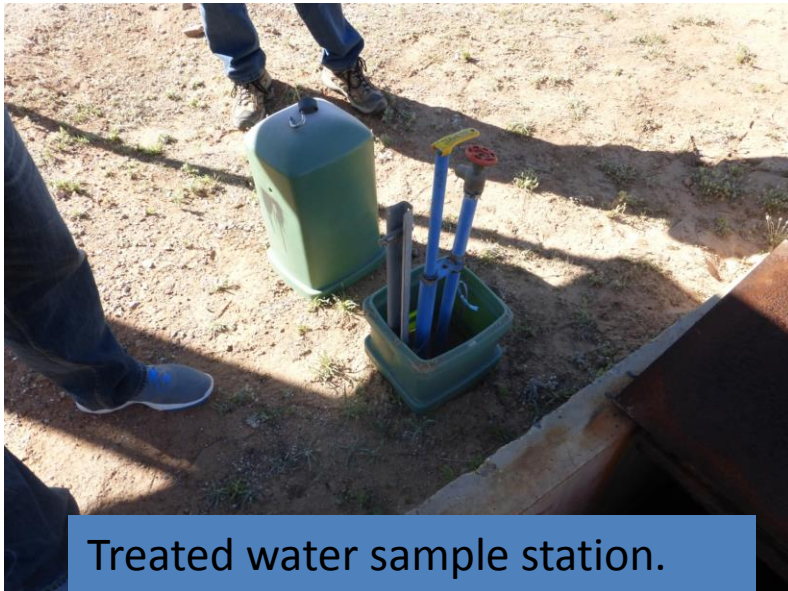
Treated water sample station.

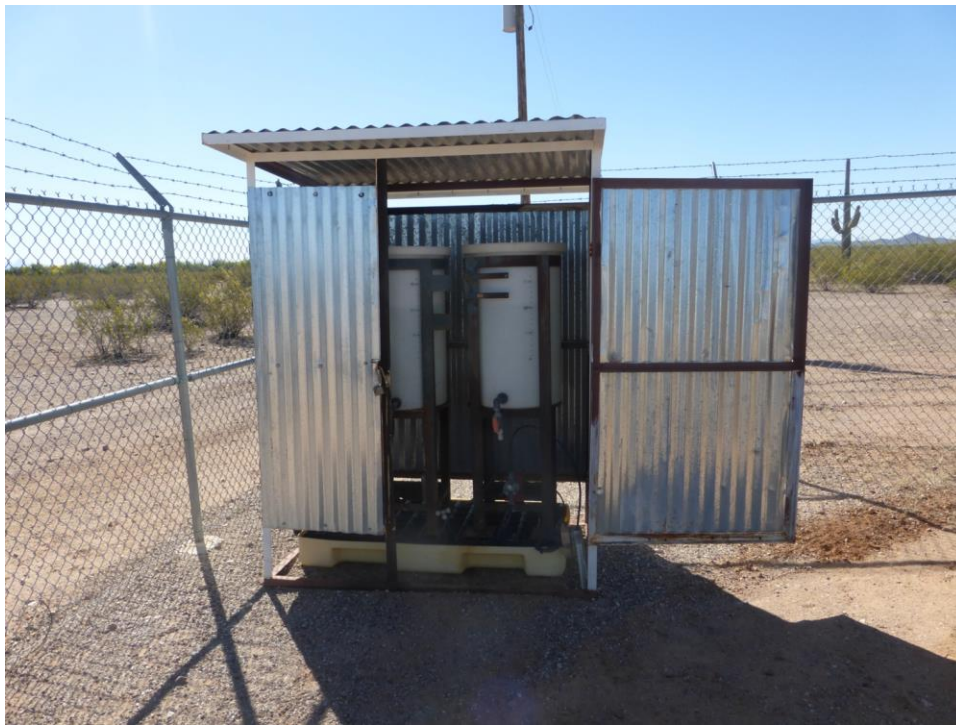
Chlorination Unit for Well 3 (TP001)

Treatment for Well 3 consists of chlorination with NSF-certified sodium hypochlorite. The chlorination unit is located in a locked structure within the fenced area for Well 3. The sodium hypochlorite is injected into the well's discharge piping (located within a buried vault adjacent to the well) with a ProMinent ConceptPlus positive displacement pump with a capacity of 1.03 gph.

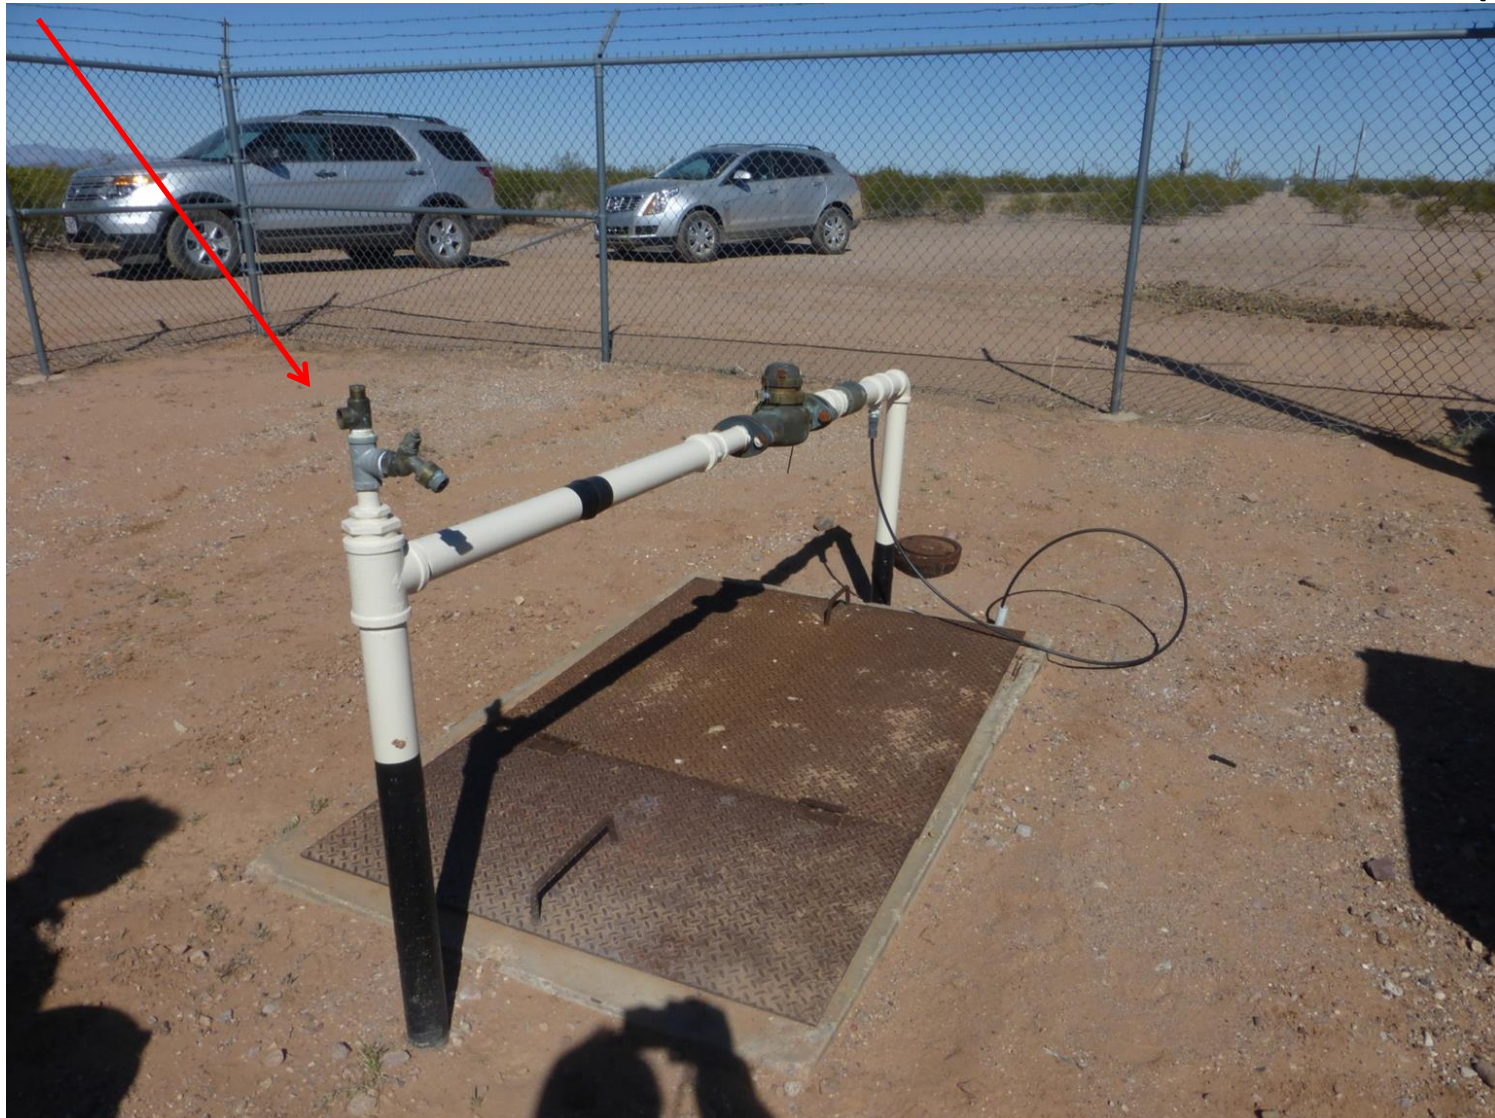
The discharge piping for the well has been brought above-grade and the vault noted during the previous survey is now empty. The wellhead discharge piping has a blowoff, raw water sample station, pressure relief valve, flow meter, and a hose bib where raw water can be obtained. The pressure relief valve is likely too small to provide adequate pressure relief for the 92 gpm flow from the well. There is no tap available to take finished water samples at the well site.

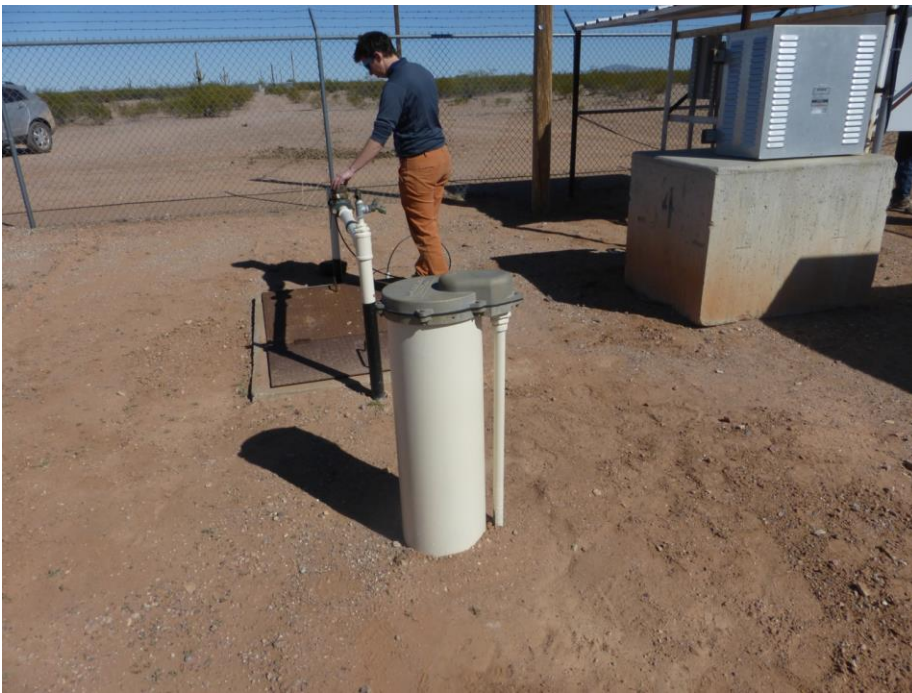
The pitless unit wellhead is equipped with a properly vented sanitary seal well cap.

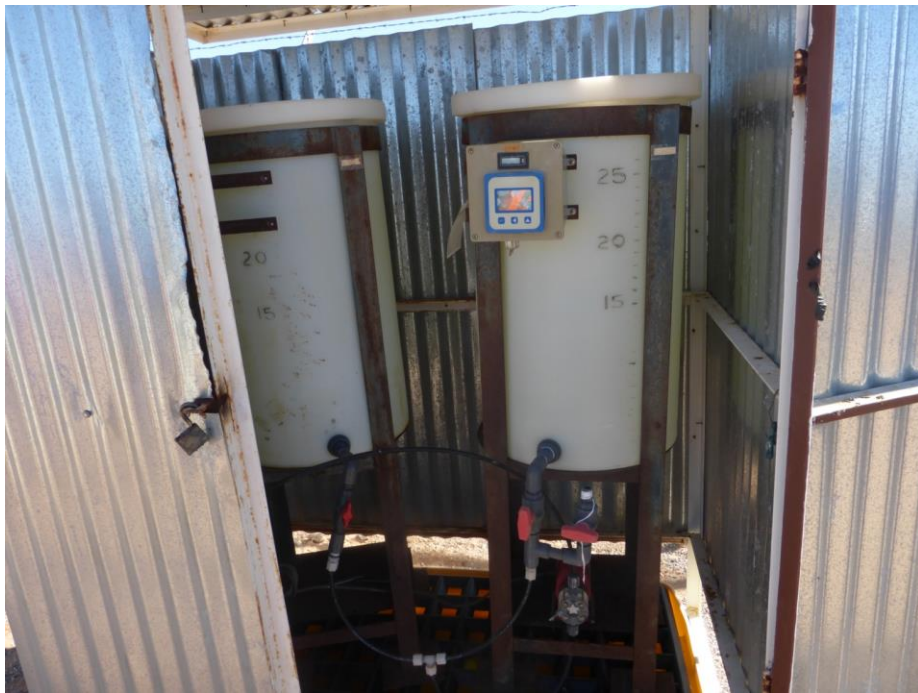
Chlorination Unit for Well 4 (TP002)

Treatment for Well 4 consists of chlorination with NSF-certified sodium hypochlorite. The chlorination unit is located in a locked structure within the fenced area for Well 4. The sodium hypochlorite is injected into the well's discharge piping with a ProMinent ConceptPlus positive displacement pump with a capacity of 1.03 gph.

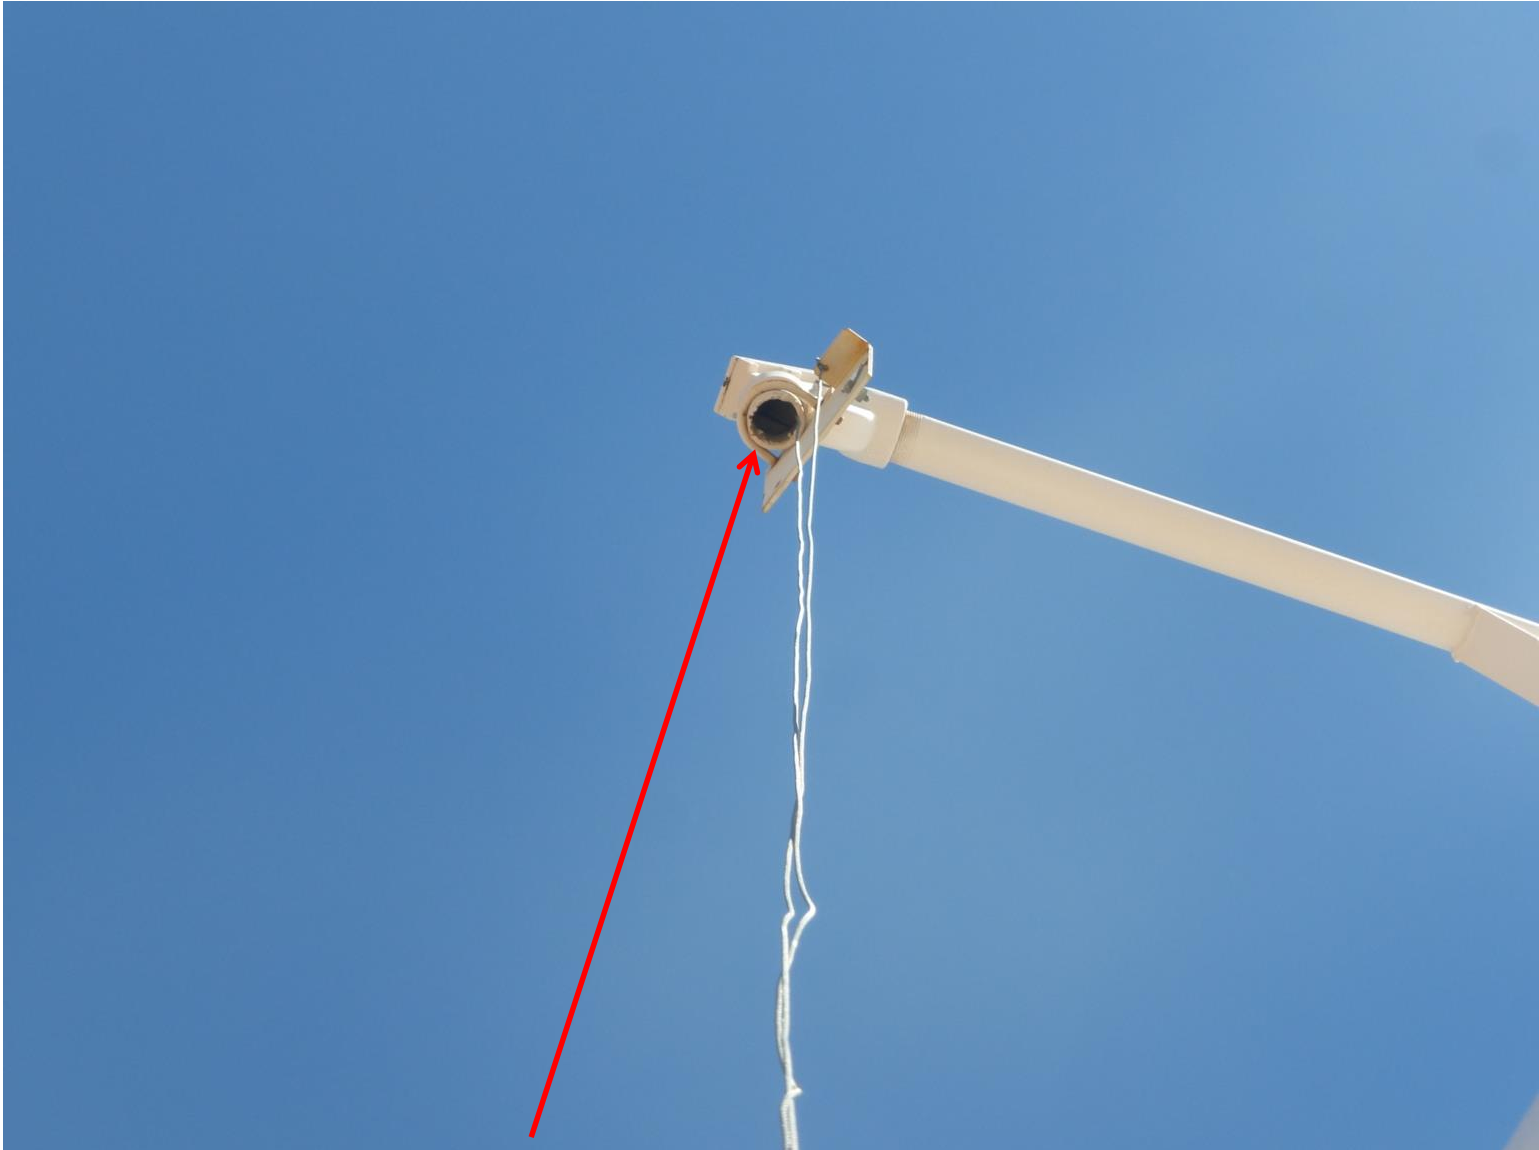
The open area between target sight gauge cable and the conduit was large and would allow entry of insects into the tank.

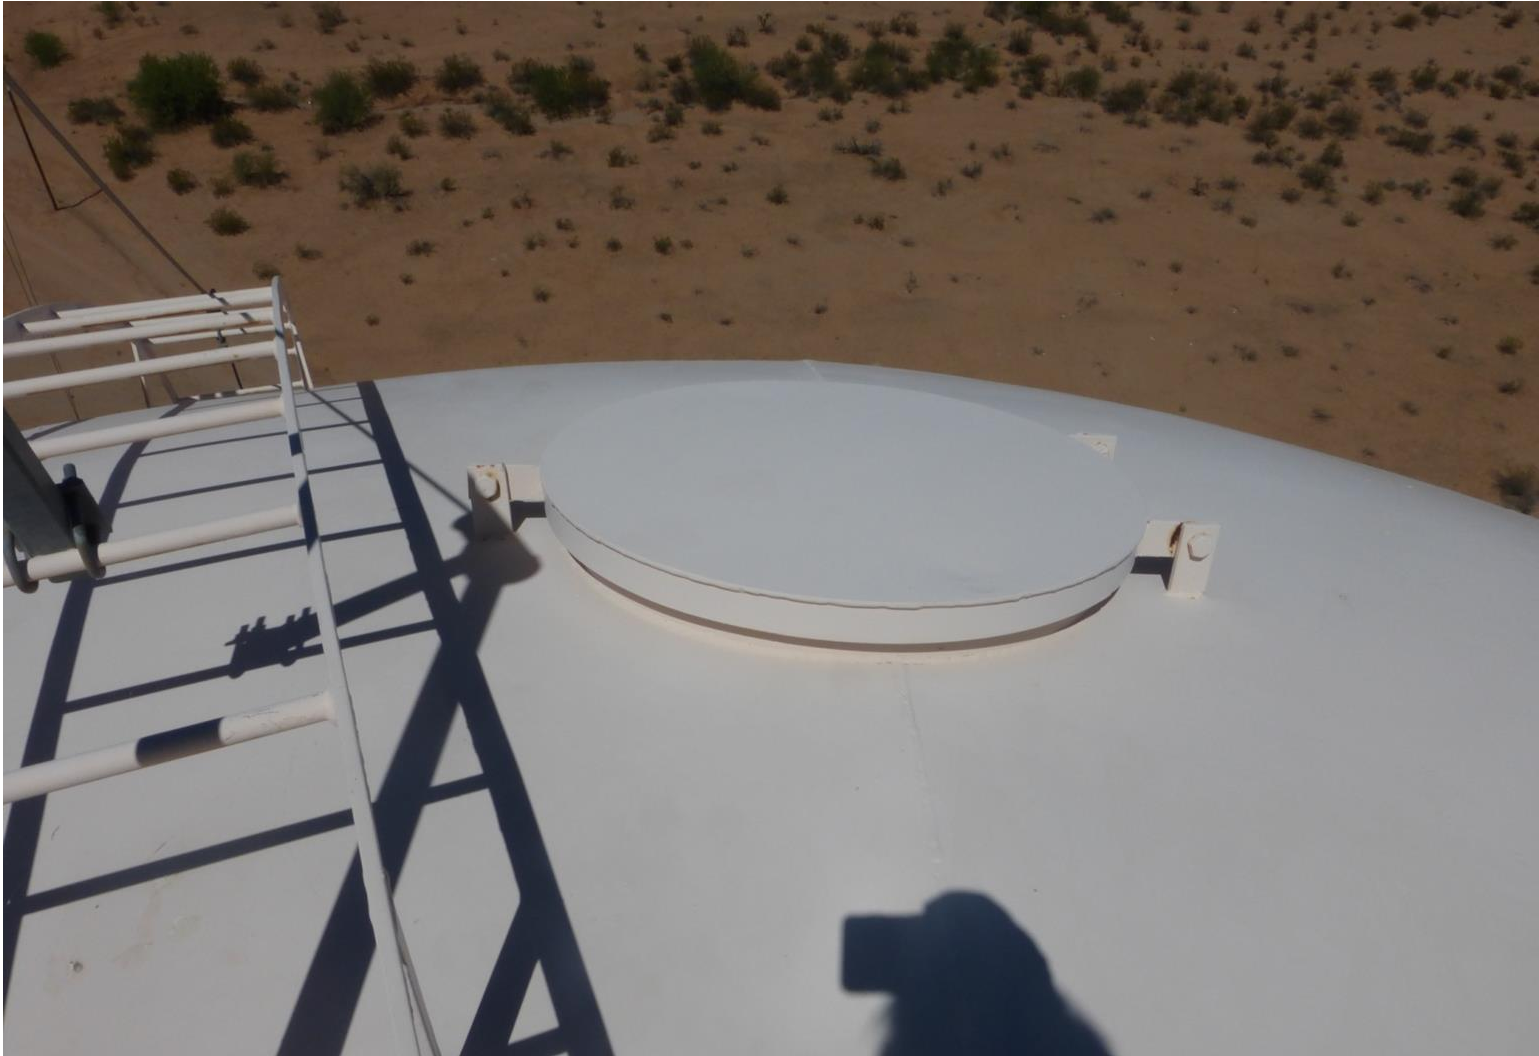
The main access hatch at the top of the tank is bolted shut on both sides and would take a wrench to open. The access hatch properly overlaps the access riser; however, it did not appear that the access hatch was equipped with a gasket (the hatch was not opened during the survey).

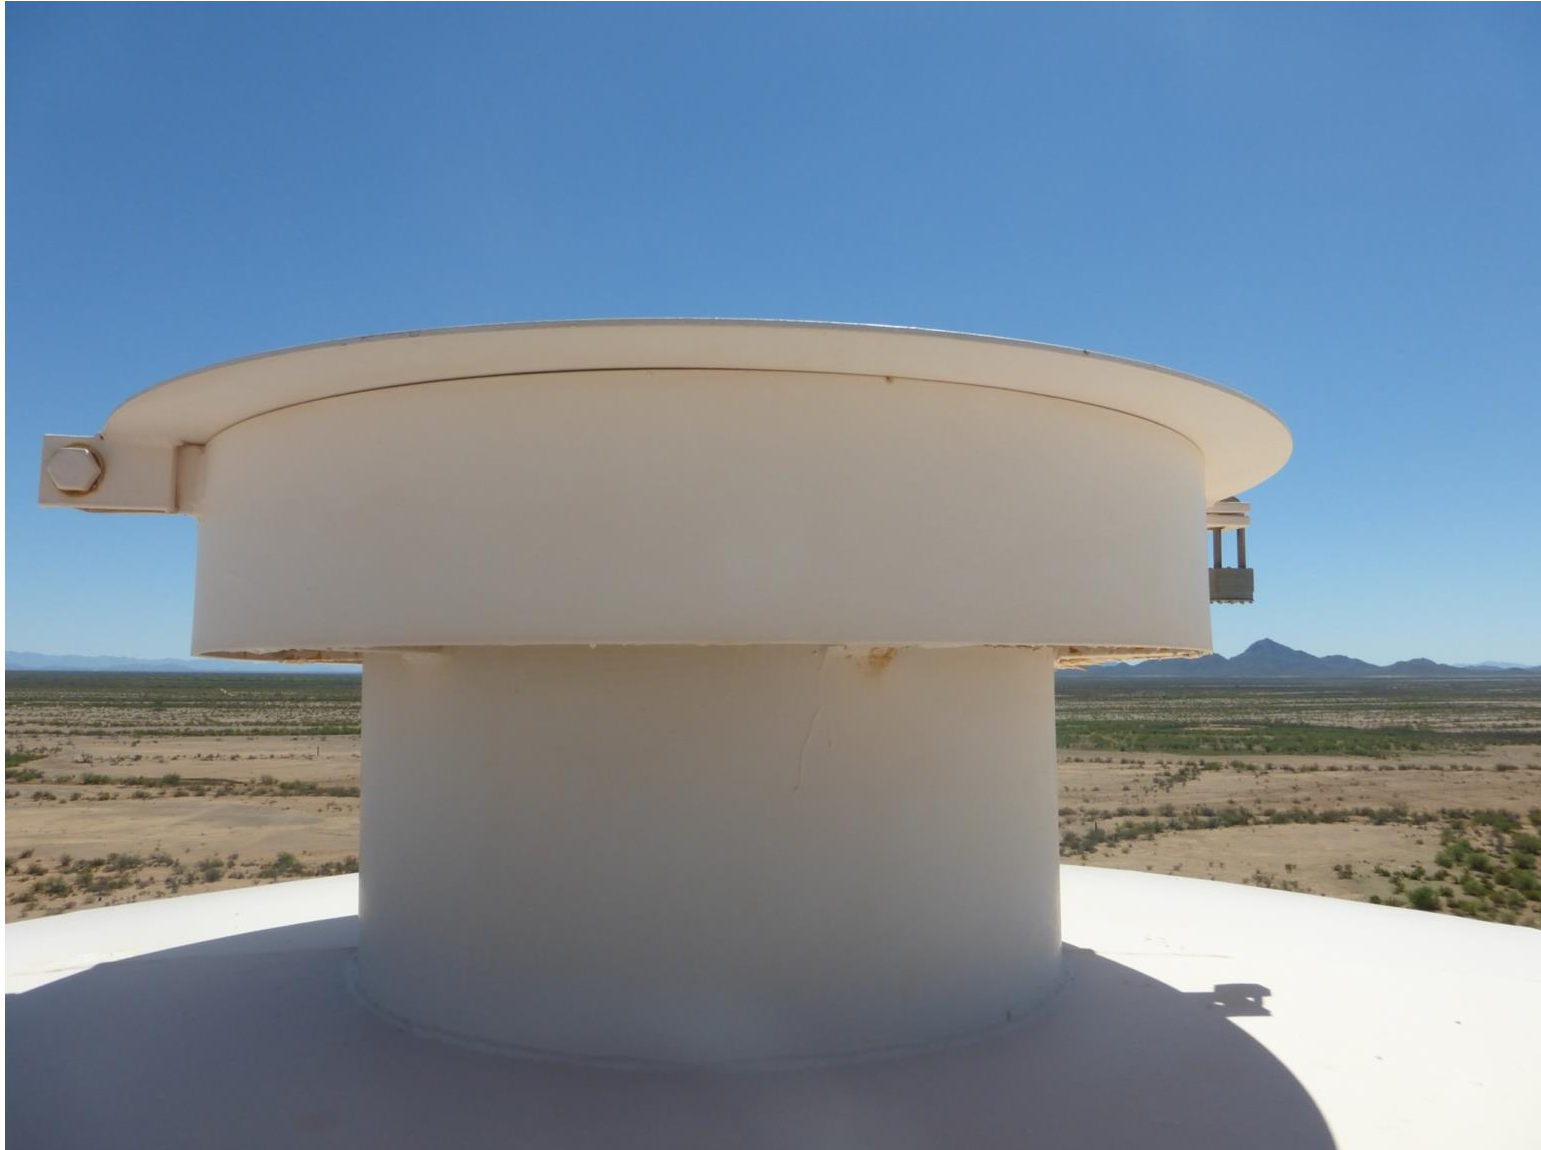
There is a locked secondary access hatch plate over the top of the vent. This hatch does not overlap the vent access and is not equipped with a gasket to ensure a tight seal.

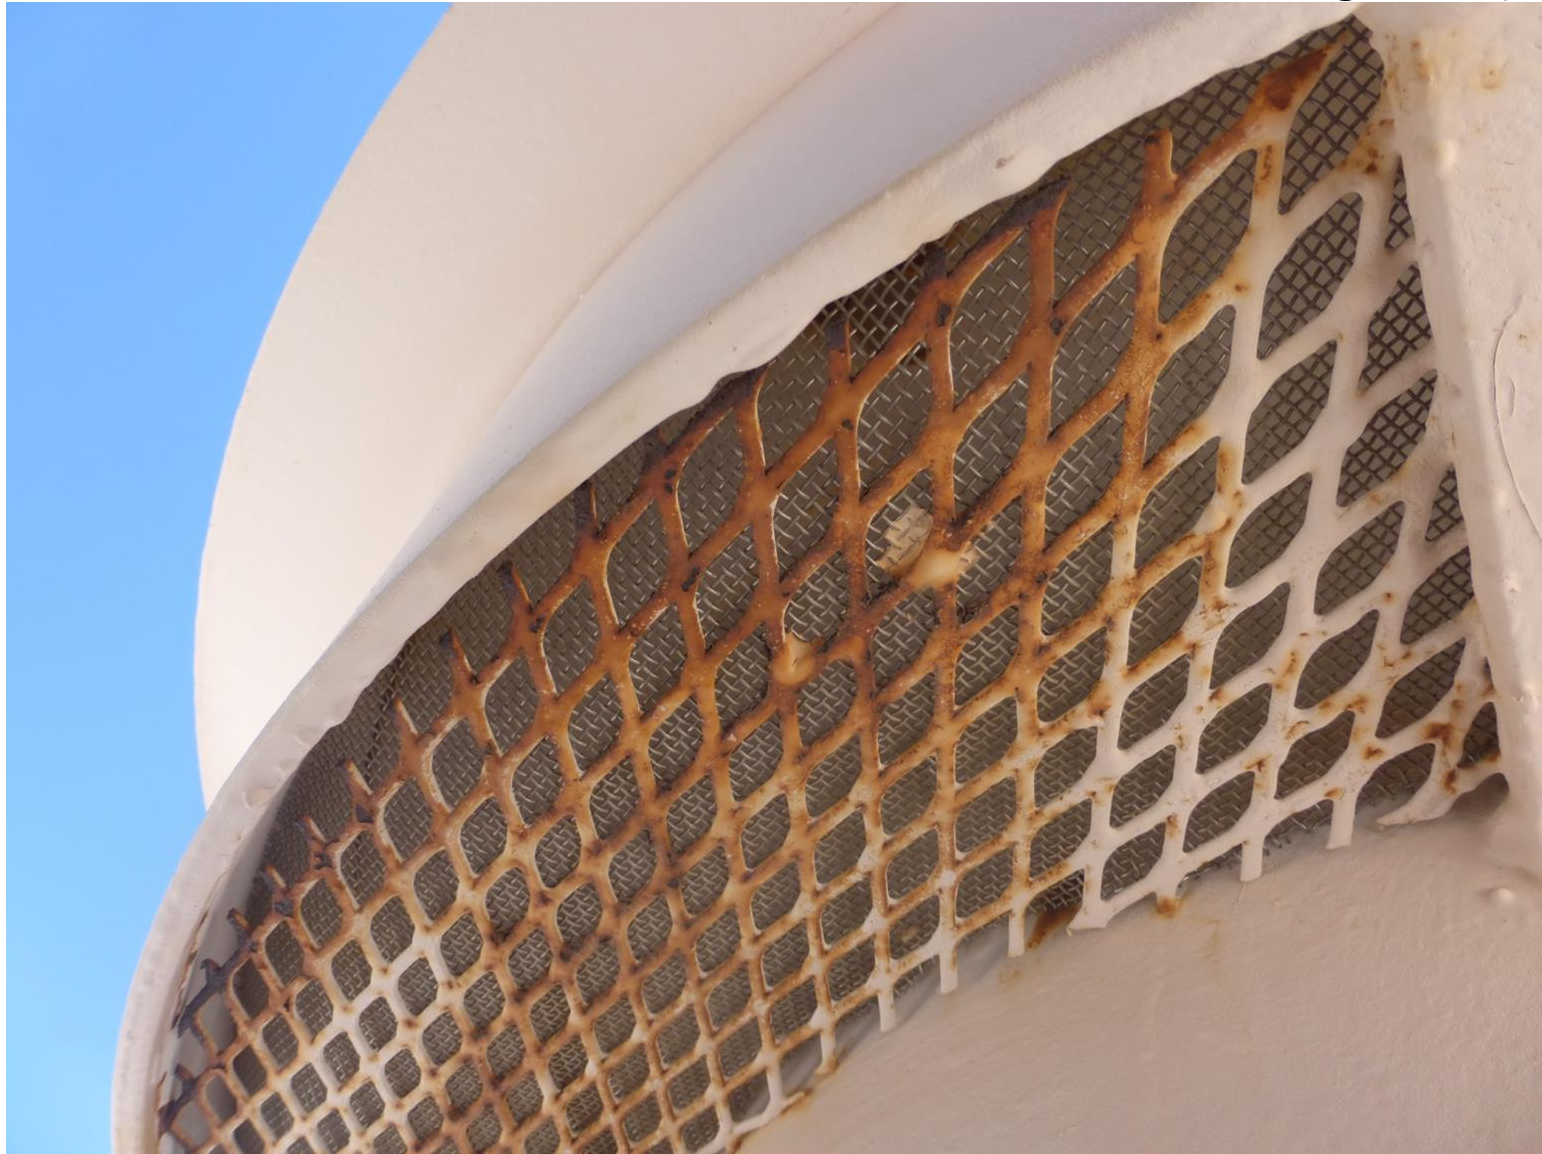
The vent is equipped with an insect screen under a coarse bird screen. A shroud cover on the vent protects the vent opening against wind-blown dust. The vent appeared to be in good condition.

Vent hatch opened.

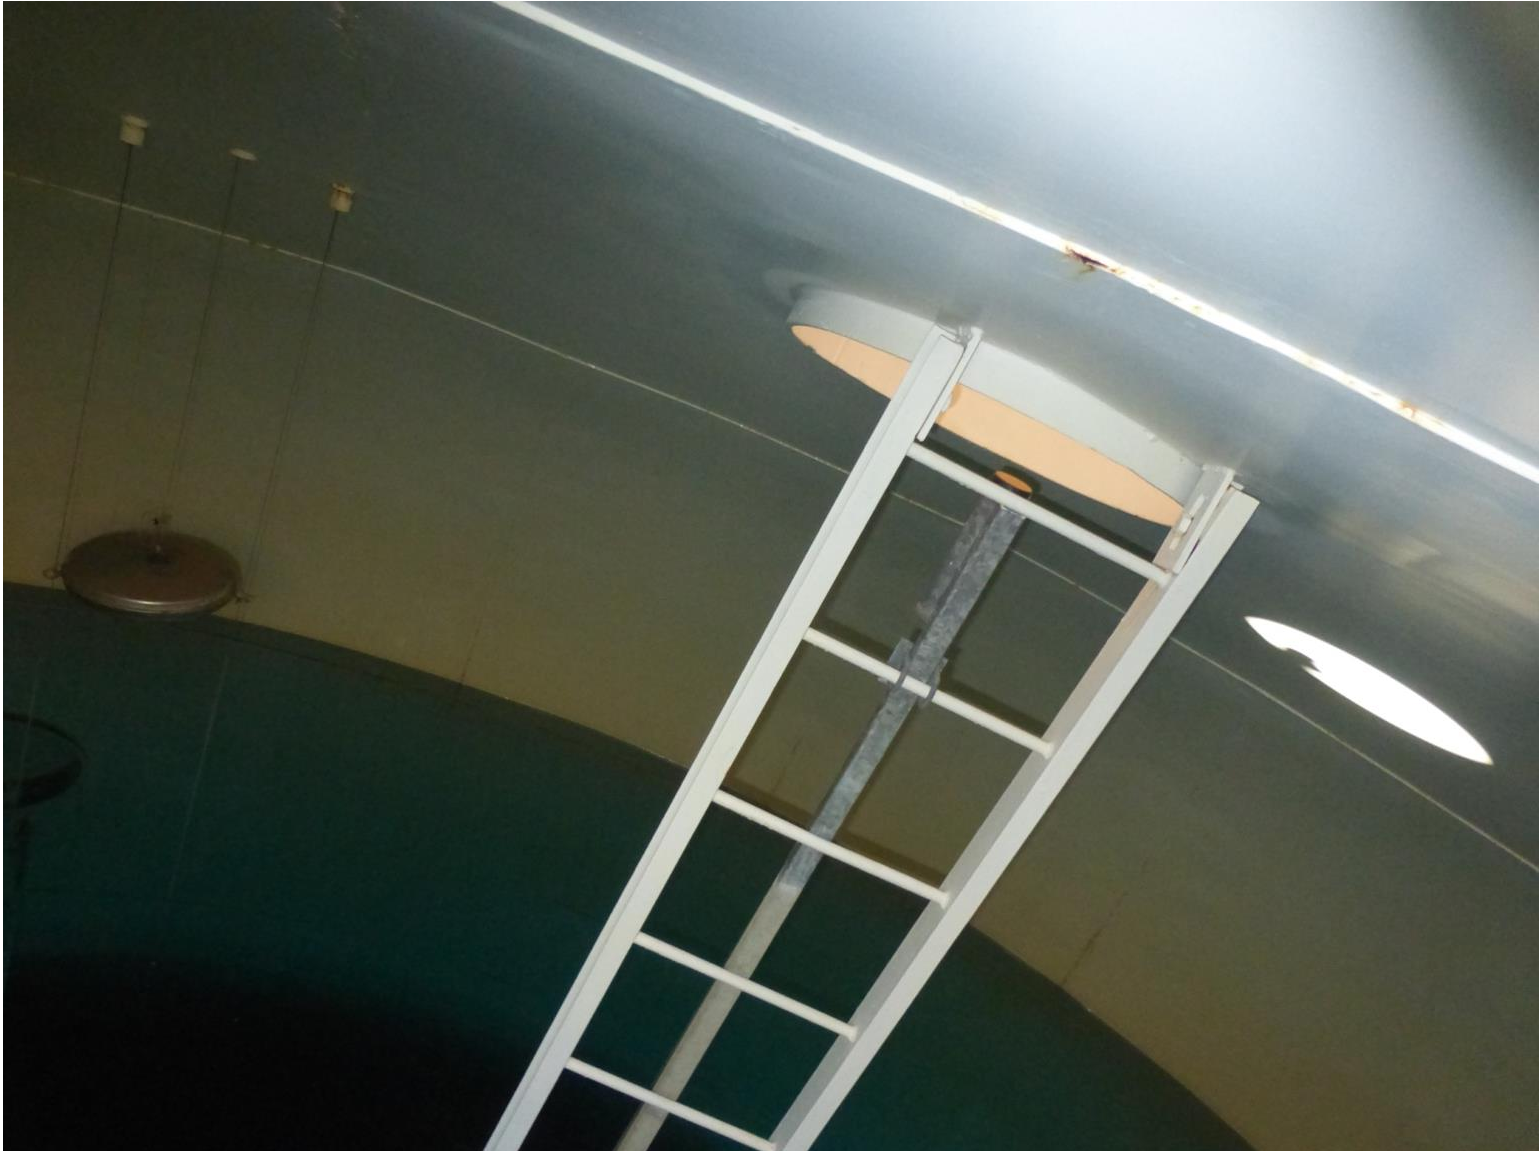
The interior of the tank appeared to be in good condition and the water appears clear, although there is some discoloration near the bottom of the tank.

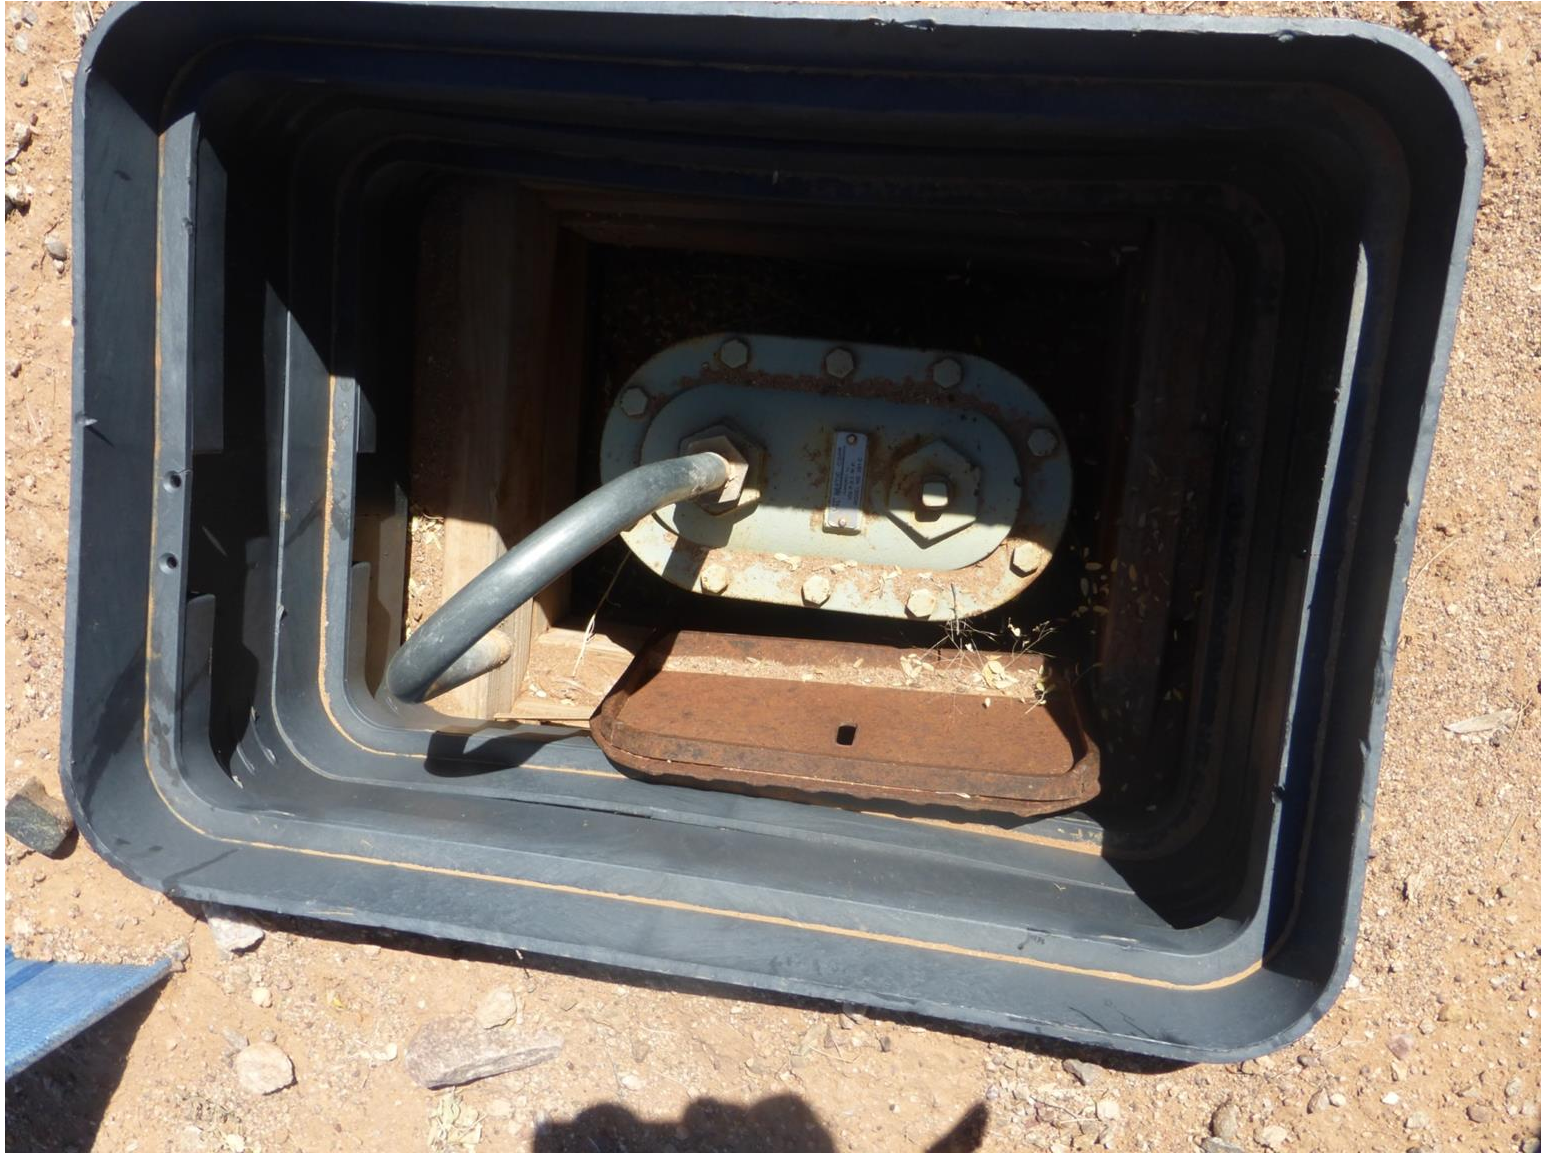
Air relief valves on transmission line with screen.
